January 11th, 2023

Buckingham Mfg. Co. has been notified by a contract supplier, that the button assembly on a limited number of Buckingham PN 5007R1 and PN 5007R2 BuckRigger™ 1.5 blocks (Fig. 1a – 1b) may not be secure. If the button comes out the side plate can open, allowing the rope to fall out which can result in serious injury or death. It was discovered that a small number of pulleys may not have had adequate thread locker or sealant, allowing the set screw to back out. Under normal circumstances, either the thread lock or sealant is adequate to secure the button and prevent this issue.

This Inspection notice affects all Buckingham PN 5007R1 and PN 5007R2 BuckRigger™ Blocks (Fig. 2a – 2b) manufactured prior to December 2022.

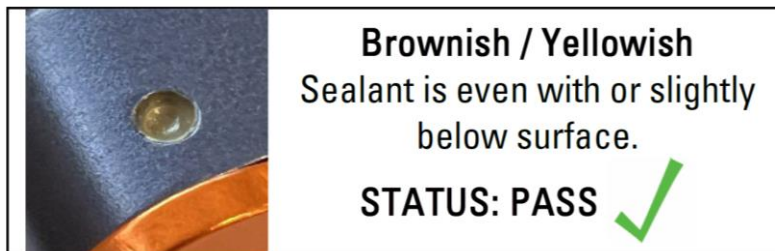
1. Identify the location of the set screw on the BuckRigger™ block, PN 5007R1 and 5007R2 and compare your block to the images below. Does your block have the sealant present and properly applied? The sealant should be brownish yellow to white / grey in color and be even or slightly below the surface of the aluminum body (Fig. 4a – 4b). If **“YES”** no further action is required.

Note: If the sealant is the proper color and is filling the hole as shown in Fig. 4a – 4b, but there is excess sealant on the surface of the aluminum body, this is not a failure. Sealant above the surface is referring only to the sealant in the hole extending above the surface (which could indicate an improperly installed set screw) and not spilled or overflow of the sealant.

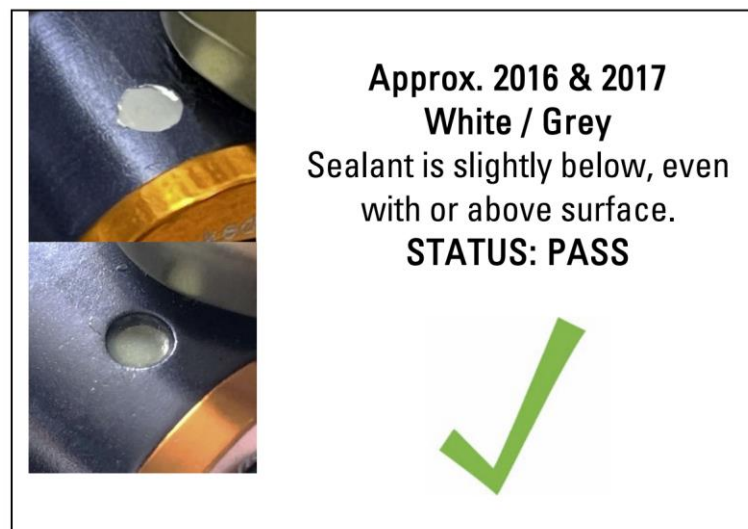
Fig. 6

1. Identify the location of the set screw on the BuckRigger™ block, PN 5007R1 and 5007R2 and compare your block to the images below. Does your block have the sealant present and properly applied? The sealant should be white / grey in color and be slightly below, even with or above the surface of the aluminum body (Fig. 6). If **“YES”** no further action is required.

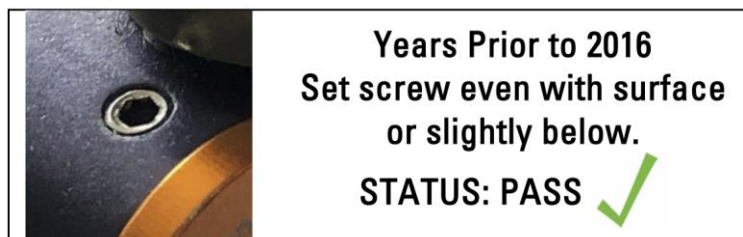
Fig. 8

1. BuckRigger™ manufactured prior to 2016 were made differently. The button set screw has thread lock but no sealant on top of it. Identify the location of the set screw on the BuckRigger™ block, PN 5007R1 and 5007R2 and compare your block to the images below. Is the set screw even with or slightly below the surface of the aluminum body (Fig. 8). If **“YES”** no further action is required.
